**U.S. Coast Guard Research and Development Center**  
1082 Shennecossett Road, Groton, CT 06340-6096

**Report No. CG-D-08-00**

**EVALUATION OF WINDOW FAILURE MODES**

**FINAL REPORT  
DECEMBER 1999**

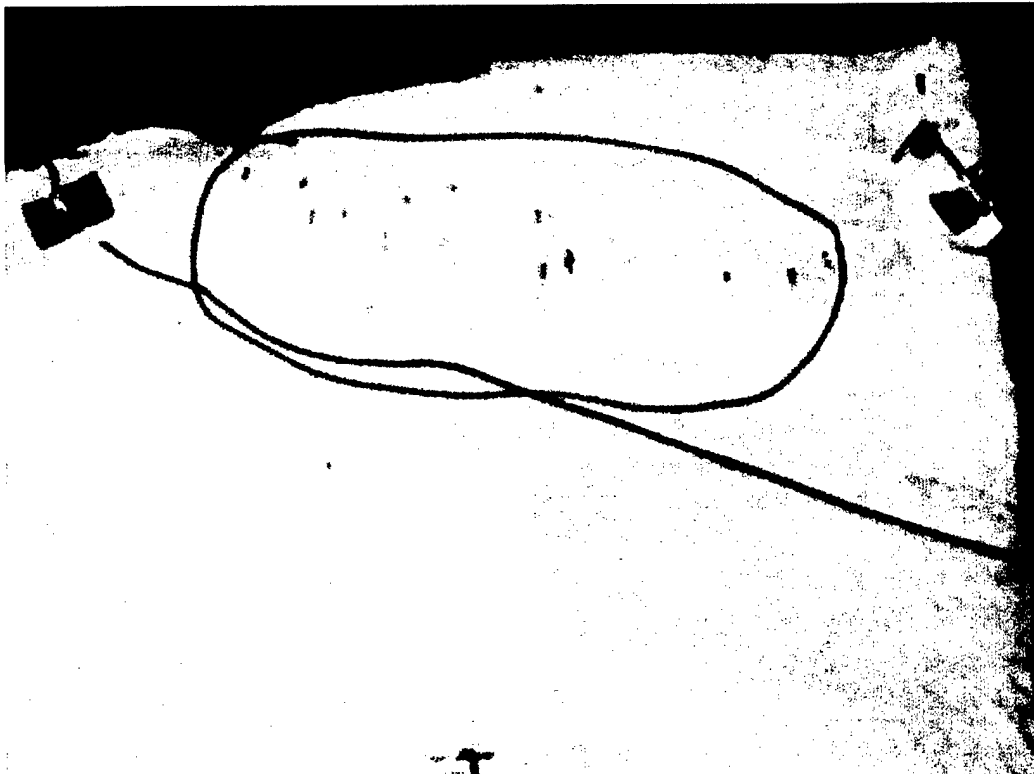
**Figure 8. Photograph of damage to the glazing.**

A second window assembly was selected for damage. In this case, the window was initially mounted into the test frame prior to damage. Once the window was properly installed in the bulkhead, the arc welding technique used to damage the first window assembly was again used, but the welding was performed in the vertical orientation. Again, damage to the glazing was accomplished (see figure 8), but it appeared that the damage to the glazing did not penetrate the glass to the depth that was noted in the first window assembly. In this instance, the window assembly was damaged on the side not directly exposed to the fire (unexposed side).

glazing and bounce off, which caused pits to form; however, these pits had a lesser depth than those formed on the horizontal glazing. These observations, along with the test results, would suggest that the depth of the damage to the glazing is an important factor in the failure of the glazing.

The testing did show that if the glazing is damaged from pitting by welding slag, it may continue to perform as required in a fire test. The amount (i.e., depth, size) of the damage is a critical factor.

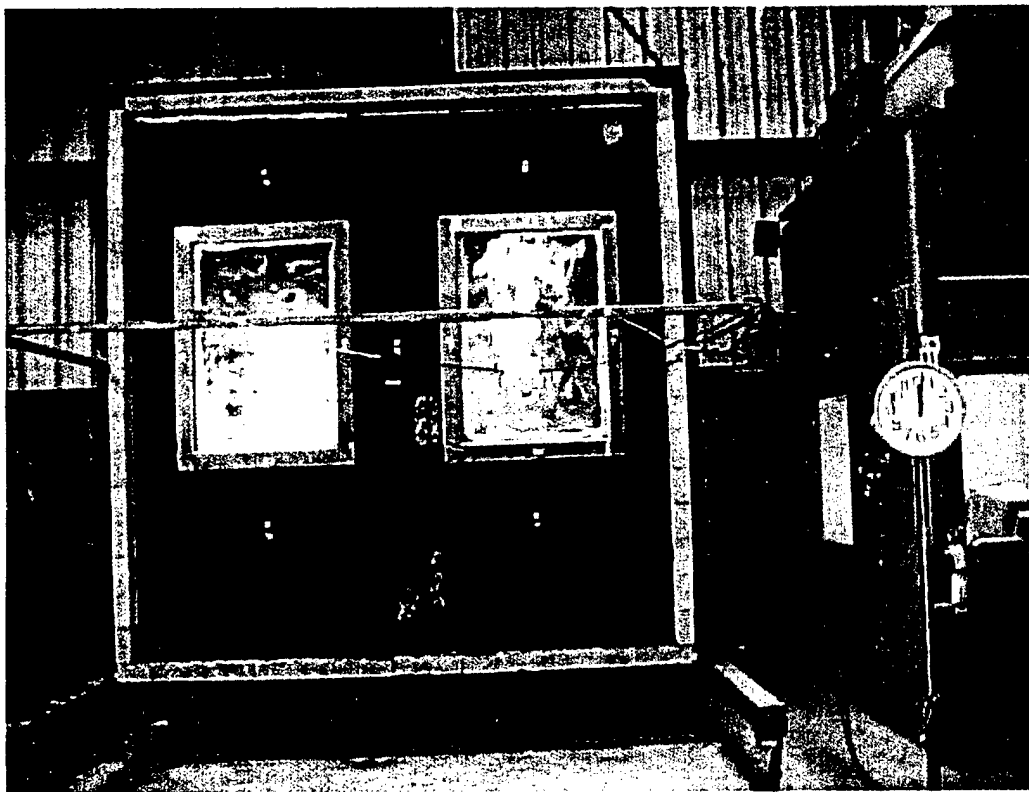
Figure 11. Photograph of test in progress.

| <b>TIME<br/>(min:sec)</b> | <b>OBSERVATION</b> |
|---|--|
| 4:38 | Inner undamaged pane of glass breaks and falls away on the damaged window |
| 4:58 | Inner pane of glass breaks and falls away on the undamaged window |
| ~5:30 | Gel on both windows has turned opaque |
| ~16:30 | Gel in both windows has turned black on exposed face |

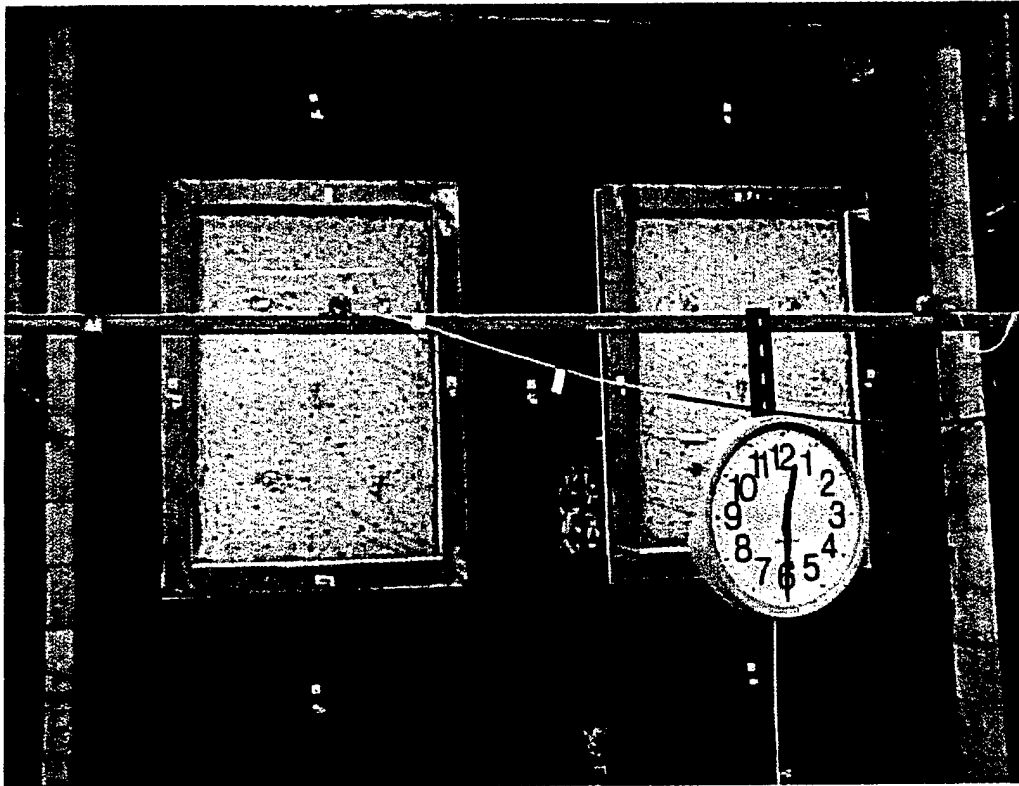
**Figure 12. Photograph of unexposed face at 30 minutes.**

During the test, the exposed layer of glass did fracture and fall from both of the assemblies. The gel did react to the heat, and it formed a char layer. The glass on the unexposed face of both window assemblies did not fracture or fall away.

Both the damaged and the undamaged window assemblies met the A-30 requirement of limiting the temperature rise for 30 minutes. The maximum measured heat fluxes were  $0.9 \text{ kW/m}^2$  on the damaged window and  $0.1 \text{ kW/m}^2$  on the undamaged window. These values were measured at the 35 minutes into the test period. In addition, on both the damaged and the undamaged windows, the unexposed side of the glazing, as well as the frame assembly, remained intact during the test.
